August 2018

On April 26, 2018, an explosion (Figure 1) and subsequent fire (Figure 2) occurred at the Superior Refinery Company LLC refinery in Superior, Wisconsin (“Husky Superior Refinery”).¹ The incident occurred in the refinery’s Fluid Catalytic Cracking Unit (FCCU). In preparation for the shutdown, the refinery brought in hundreds of contractors and increased operations staffing. The contractors were performing many tasks such as electrical work, preparing for chemical cleaning, building scaffolding, and welding. As a result of the explosion, thirty-six people sought medical attention, including eleven refinery and contract workers who suffered OSHA recordable injuries. In addition, a large portion of Superior,² Wisconsin was evacuated.

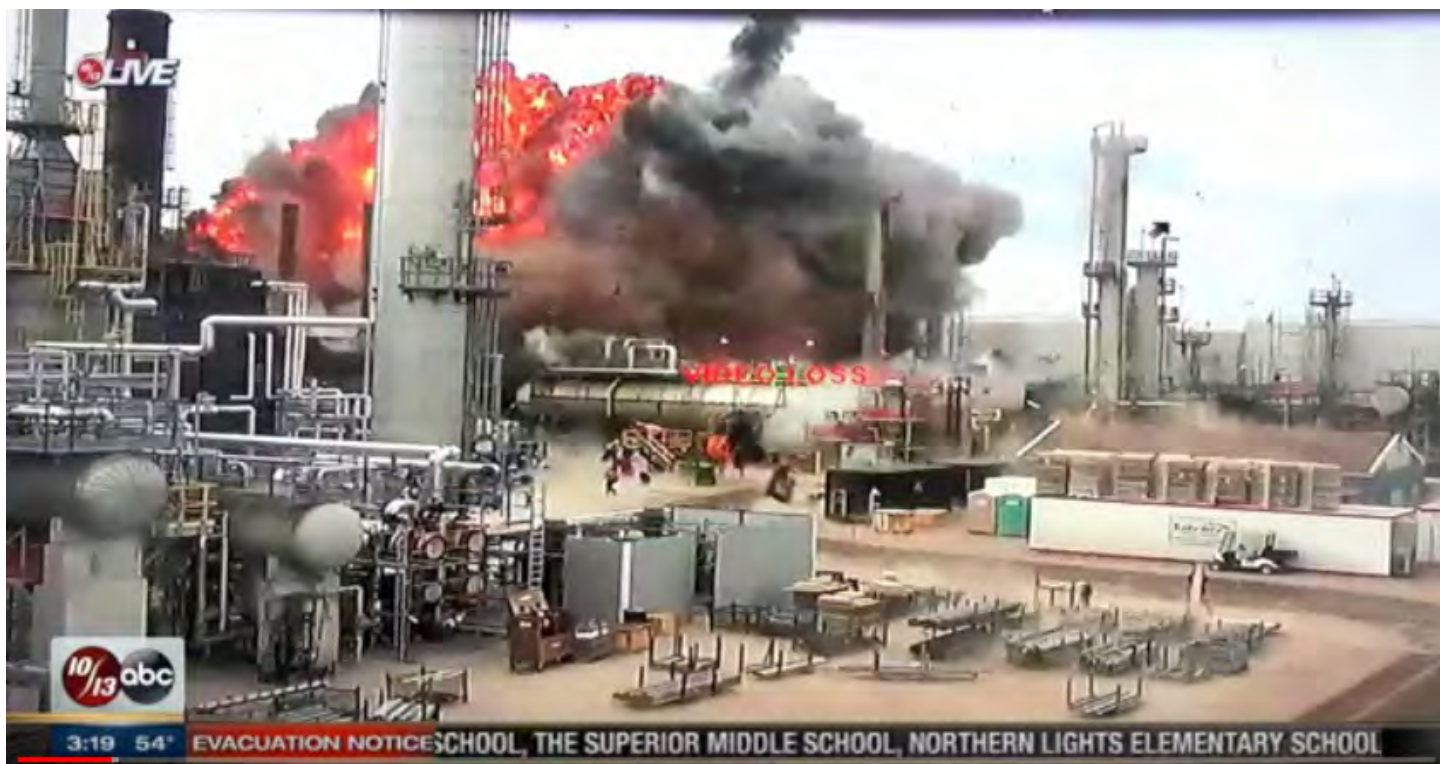
Figure 1. Surveillance Camera Image of the Husky Superior Refinery Explosion. Credit: WDIO ABC News.

The explosion occurred around 10:00 am on April 26, 2018, while the refinery was shutting down the FCCU for periodic maintenance and inspection. The explosion occurred during a scheduled break

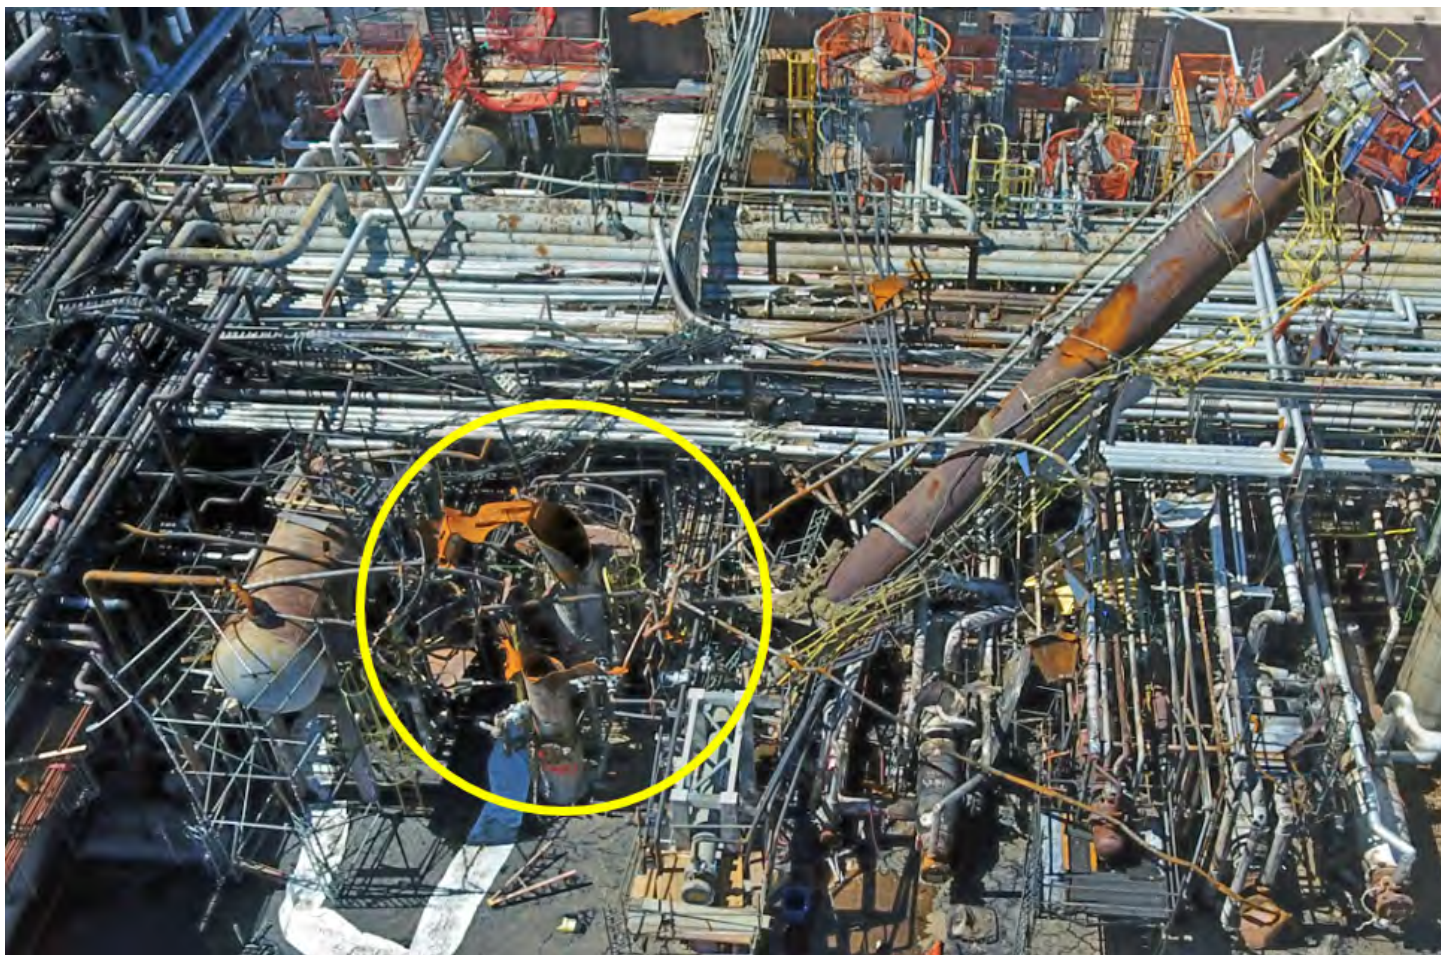
Figure 3. Two of the Vessels Destroyed in the Explosion at the Husky Superior Refinery (yellow circle). The photo shows that only the bottom portion of the two process vessels remained after the explosion. The remaining portions of the vessels were blown into surrounding units of the refinery. Credit: Husky Superior Refinery.

Two FCCU vessels,⁶ the primary absorber⁷ and sponge absorber⁸

7 The dimensions of the primary absorber were 36 inches (internal diameter) by 69.5 feet tall. The vessel had a maximum allowable working pressure of 250 pounds per square inch at 150 °F. The primary absorber was constructed in 1961 using SA-212-B steel and the vessel was not stress relieved.

8 The dimensions of the sponge absorber were 30 inches (internal diameter) by 48 feet tall. The vessel had a maximum allowable working pressure of 250 pounds per square inch at 150 °F. The sponge absorber was constructed in 1961 using SA-201-A steel and the vessel was not stress relieved.

(Figure 3), were destroyed in the explosion. The primary and sponge absorbers serve to recover heavy hydrocarbons⁹ from a gas stream by mixing the gas stream with a liquid stream that absorbs the heavy hydrocarbons.

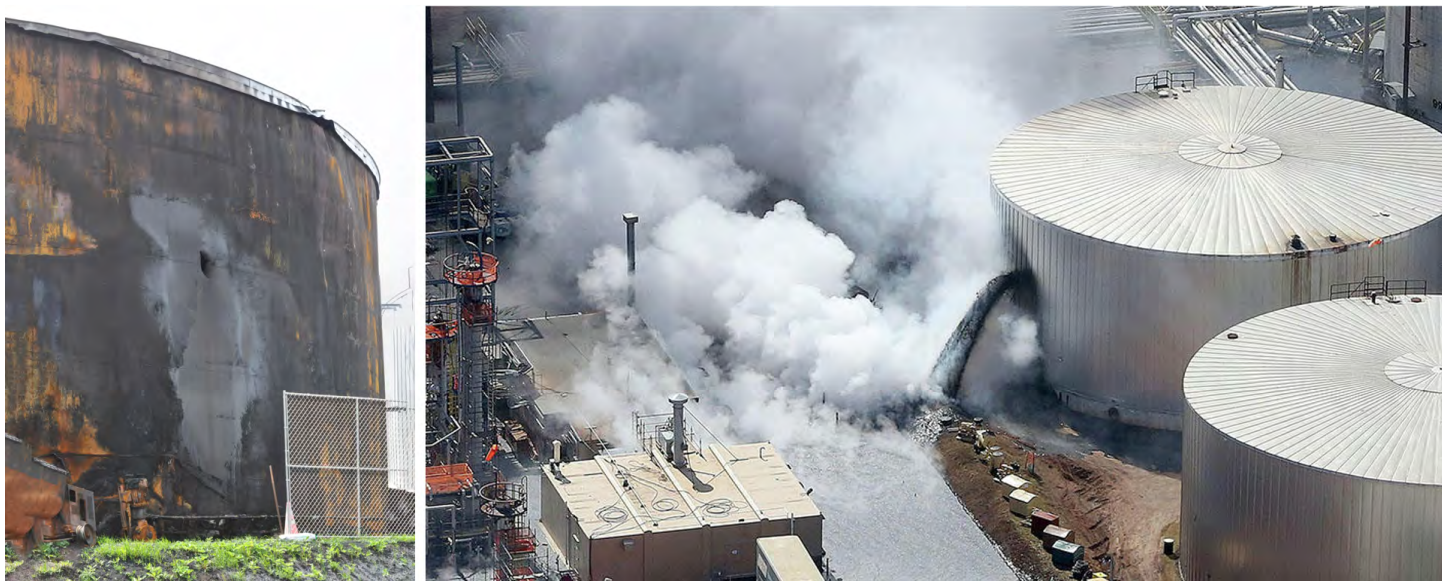
Debris from the explosion flew about 200 feet, and impacted a large, nearby, aboveground storage tank containing about 50,000 barrels of asphalt, puncturing the side of the steel tank and spilling over 15,000 barrels of hot asphalt into the refinery (Figure 4). This released asphalt ignited about two hours after the explosion, creating a large fire.

Figure 4. Post-incident photographs of the leaking Asphalt Storage Tank. Debris from the explosion punctured the side wall of the tank creating a large asphalt leak outside of the secondary containment area. Credit: CSB (left) Duluth News Tribune (right).
