August 2018

On April 26, 2018, an explosion (Figure 1) and subsequent fire (Figure 2) occurred at the Superior Refinery Company LLC refinery in Superior, Wisconsin (“Husky Superior Refinery”).¹ The incident occurred in the refinery’s Fluid Catalytic Cracking Unit (FCCU). In preparation for the shutdown, the refinery brought in hundreds of contractors and increased operations staffing. The contractors were performing many tasks such as electrical work, preparing for chemical cleaning, building scaffolding, and welding. As a result of the explosion, thirty-six people sought medical attention, including eleven refinery and contract workers who suffered OSHA recordable injuries. In addition, a large portion of Superior,² Wisconsin was evacuated.

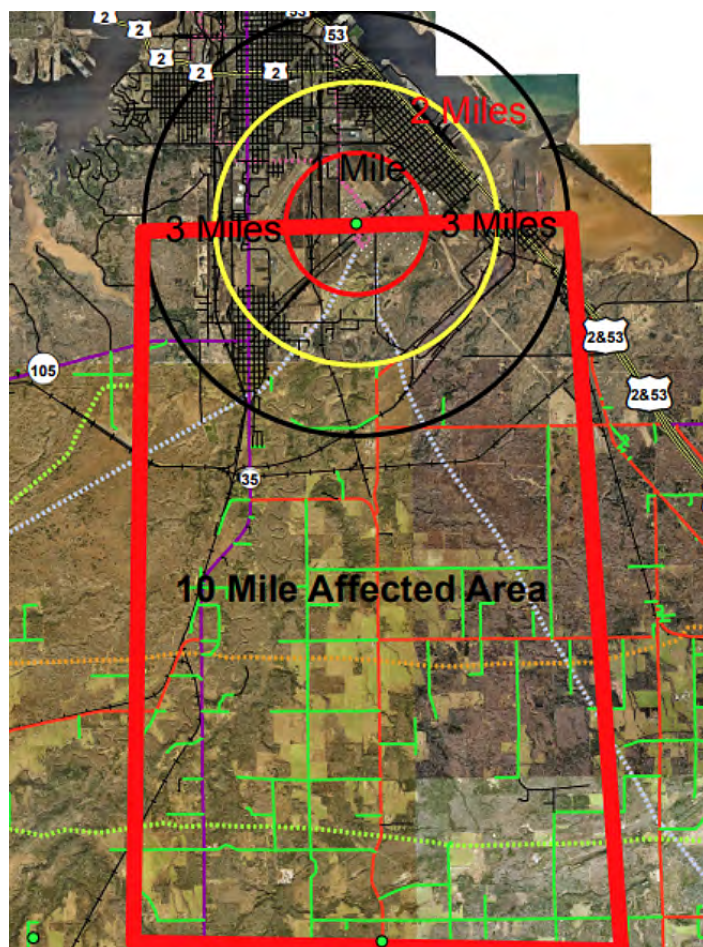
Around 12:15 pm the spilled asphalt ignited, creating a large fire spanning multiple units at the refinery. Because this fire risked compromising other process equipment containing hazardous chemicals, the Unified Command issued its first community evacuation notice at 1:00 pm. By 2:41 pm, the evacuation zone consisted of a 3-mile radius around the refinery, and a 10-mile rectangle extending south from the refinery (Figure 5). The evacuation zone size was established to protect the public from the smoke plume and as a precaution in case the refinery's highly toxic hydrofluoric acid equipment was compromised.¹⁰

Figure 5. Evacuation Zone on April 26, 2018. Credit: Douglas County, Wisconsin.
